In-situ application of elemental nanoiron into the subsurface polluted with chlorinated ethylenes

**INSTITUTE OF
CHEMICAL TECHNOLOGY
PRAGUE**

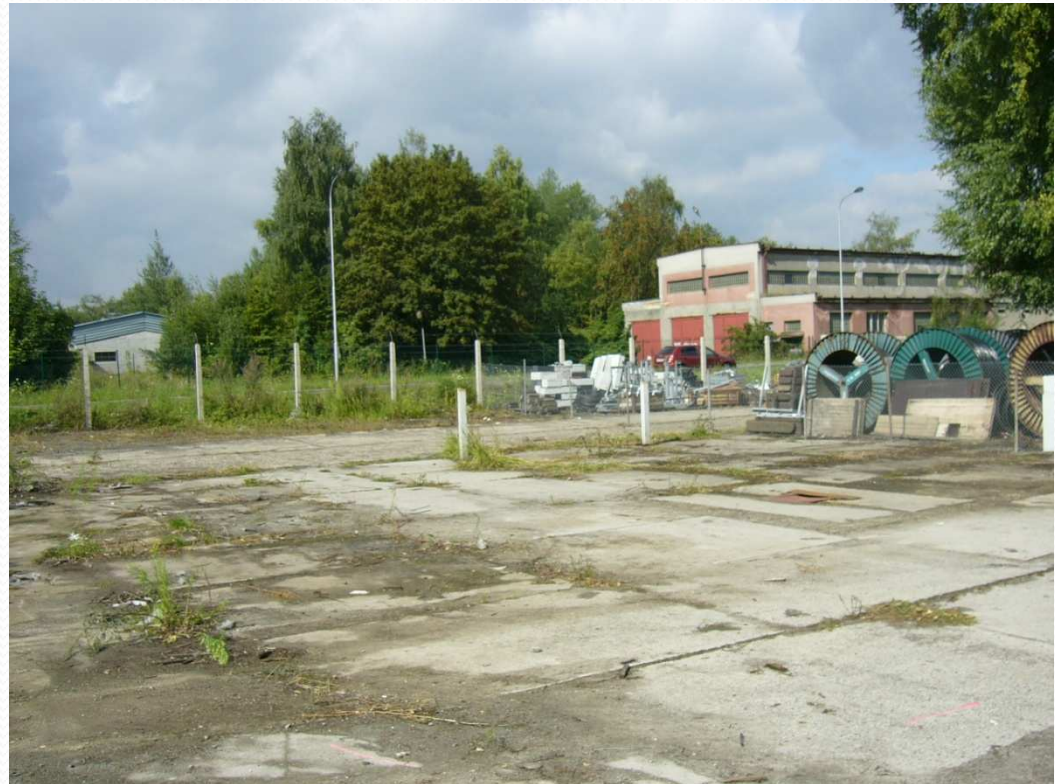
Groundwater quality within the contaminated area

- Disclosure of contamination in 2001
- Main contaminant dichlorethylene (DCE)

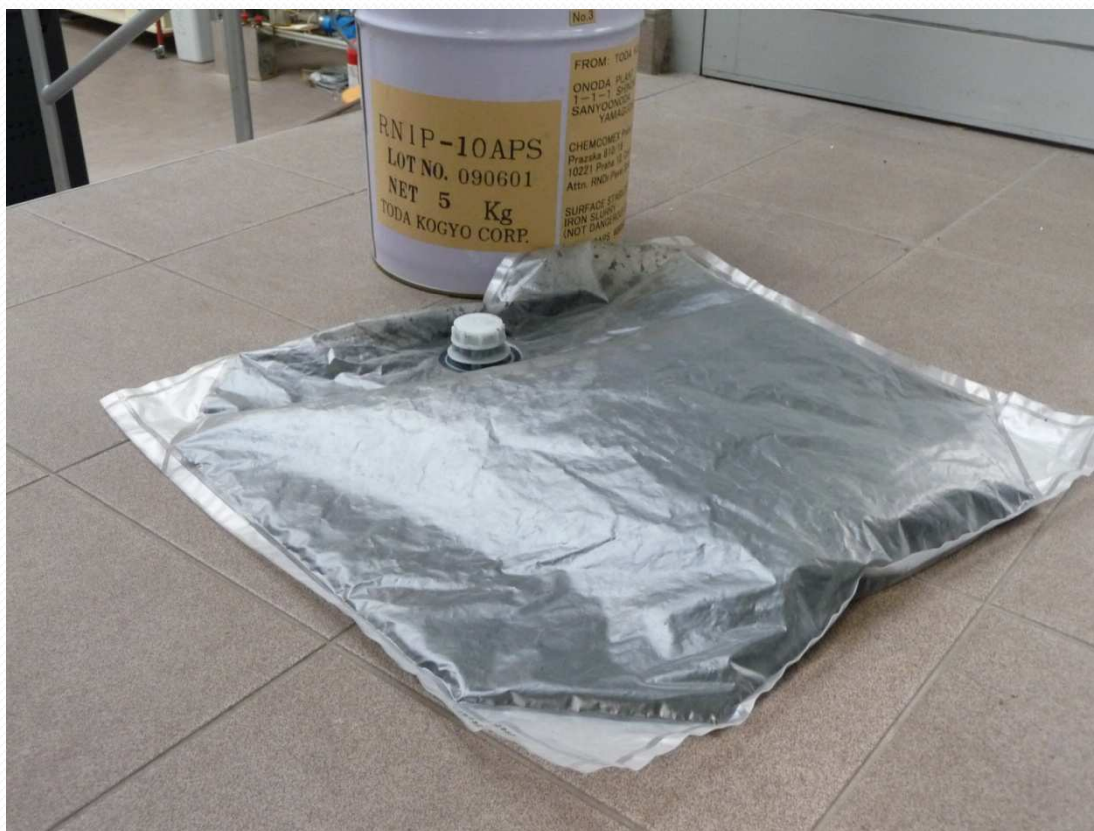
RNIP-10APS

- Physical properties
 - Diameter ~ 70 nm
 - Surface ~ 30 m²/g
- Chemical properties
 - 5 -17 % Fe⁰
 - 1 – 12% Fe₃O₄
 - 75 – 85% water
- Stabilization by polycarboxylic acid

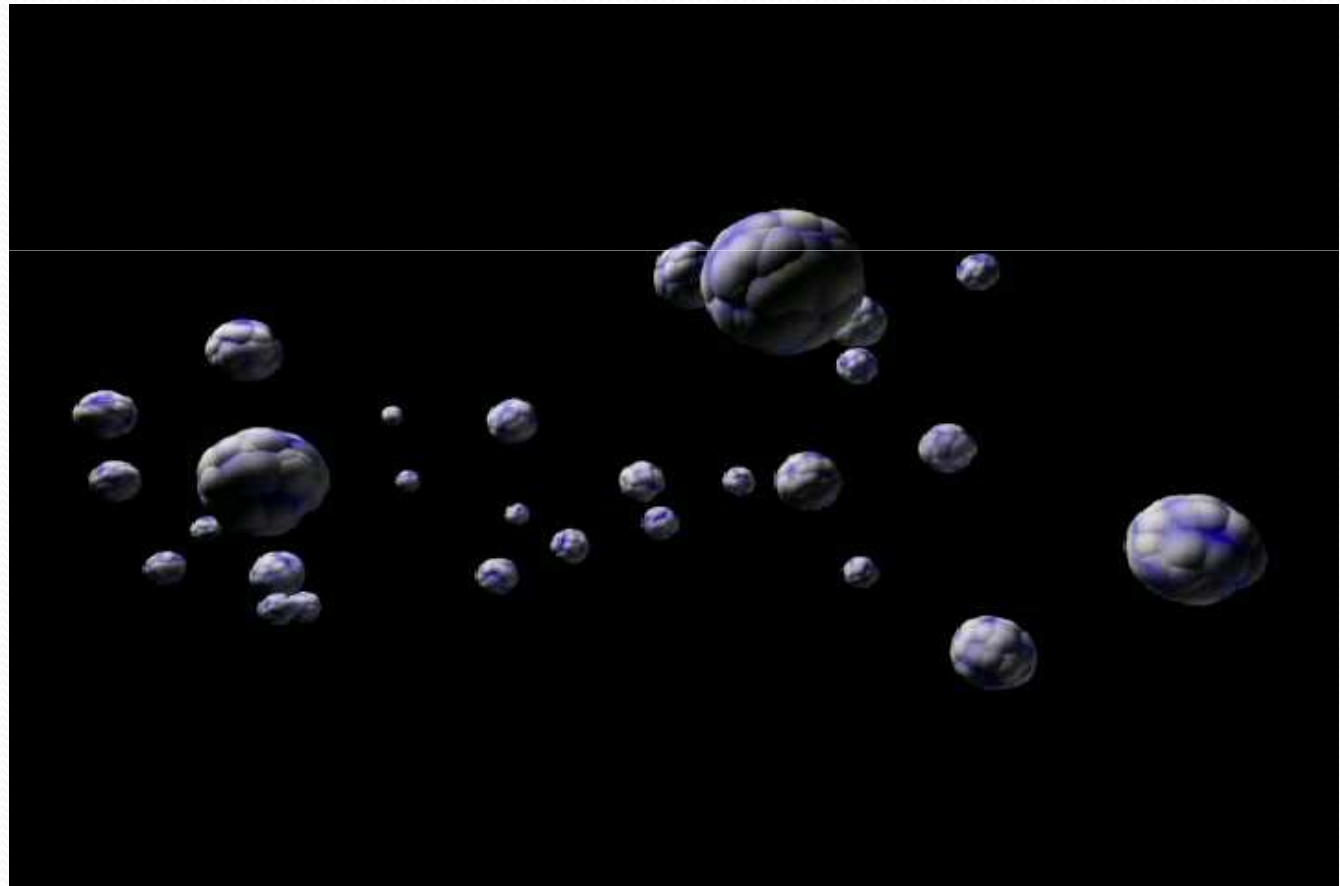
- Particles tend to agglomerate in aqueous media
- Deagglomeration and stabilization to some extent is possible

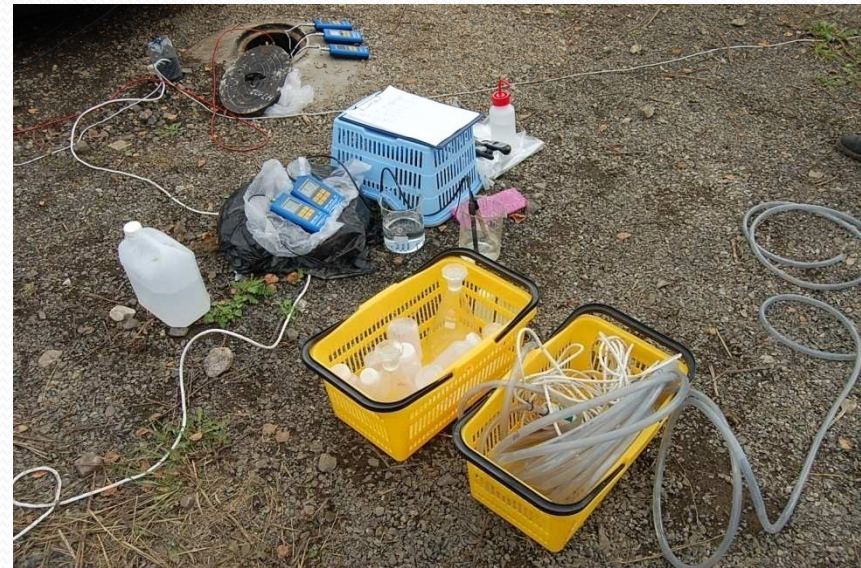
First application – 15.9.09

- application of (RNIP 10-APS) nanoiron followed by three weeks periodical sampling of the monitoring wells,
- 2.5 kg of nanoiron
- Injection volume 750 L
- Average injection rate 0.89 L.s^{-1}

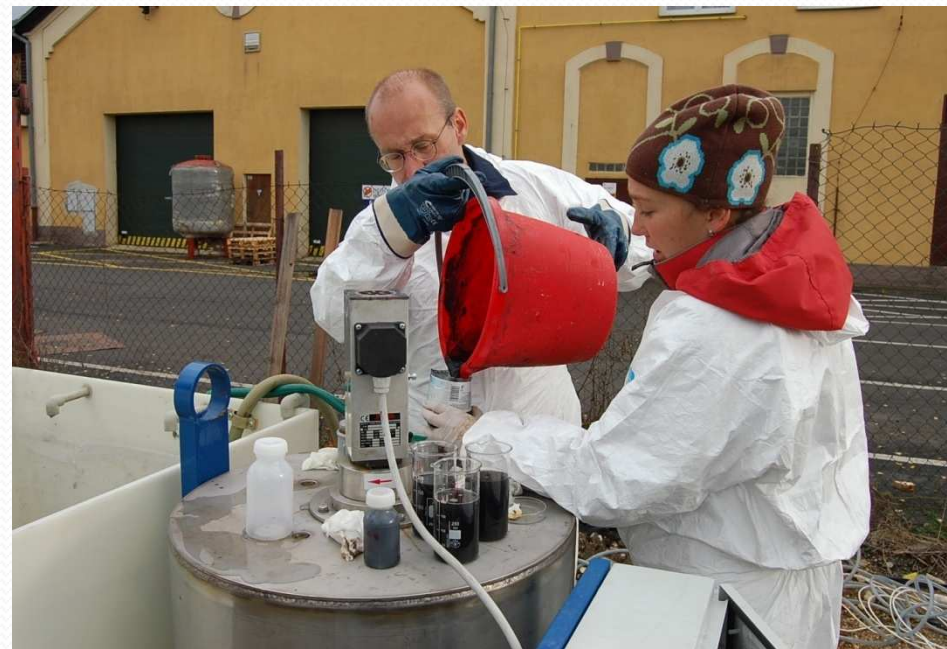
Second application– 14.10.09

- application of (RNIP 10-APS) nanoiron with modified surface followed by three weeks periodical sampling of the monitoring wells
- 10 kg of nanoiron
- Injection volume 1500 L
- Average injection rate 0.89 L.s⁻¹

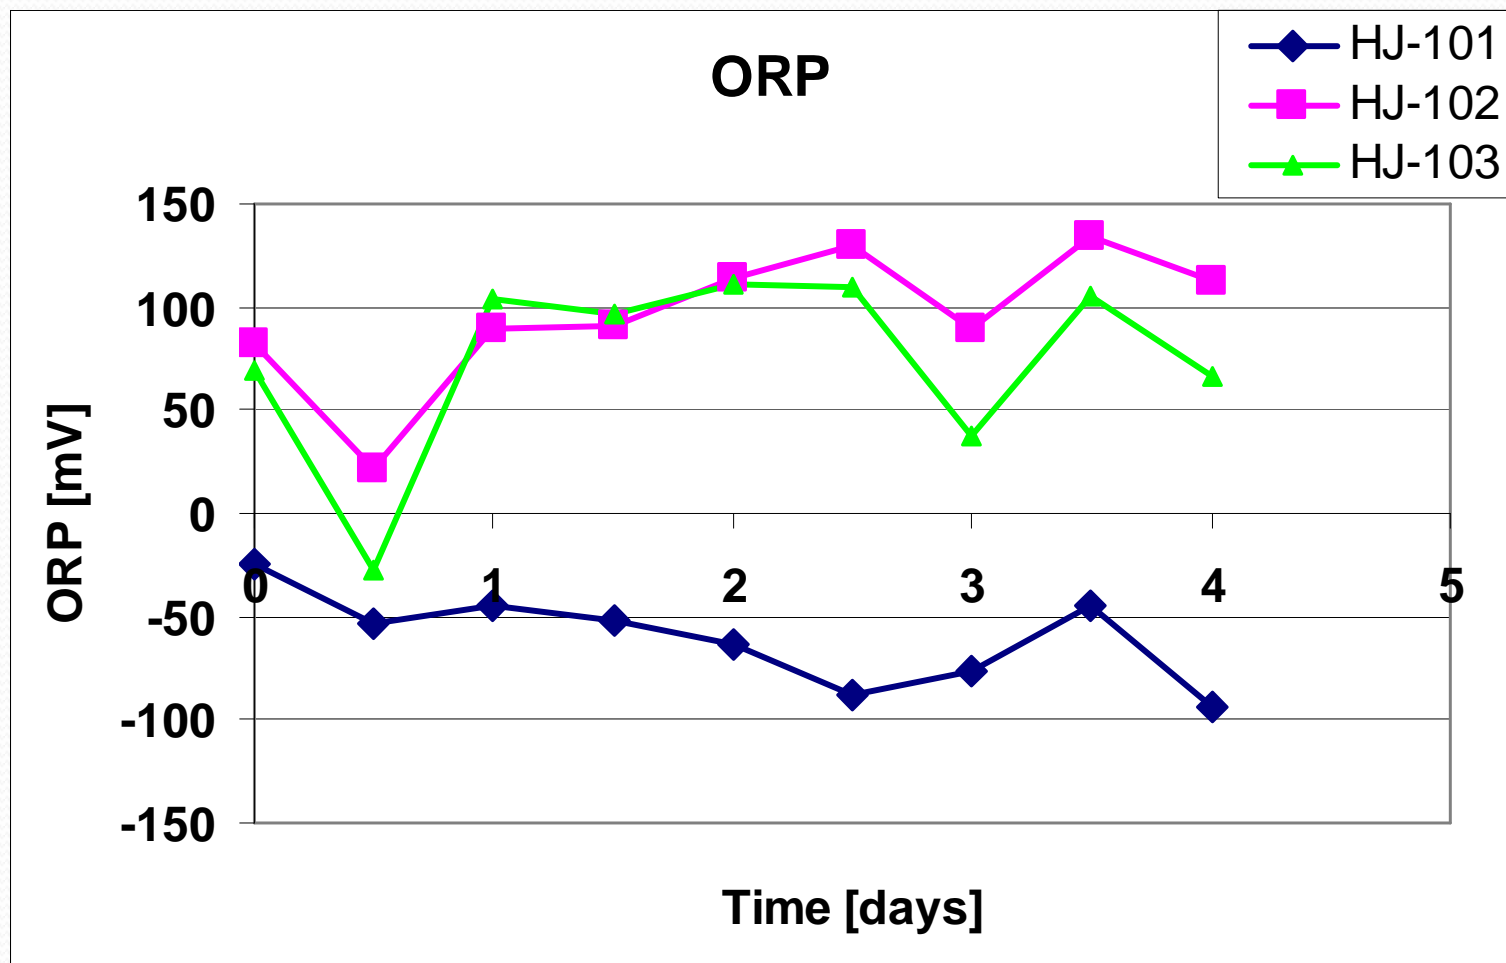
Results of injection 15.9.09 – changes in ORP

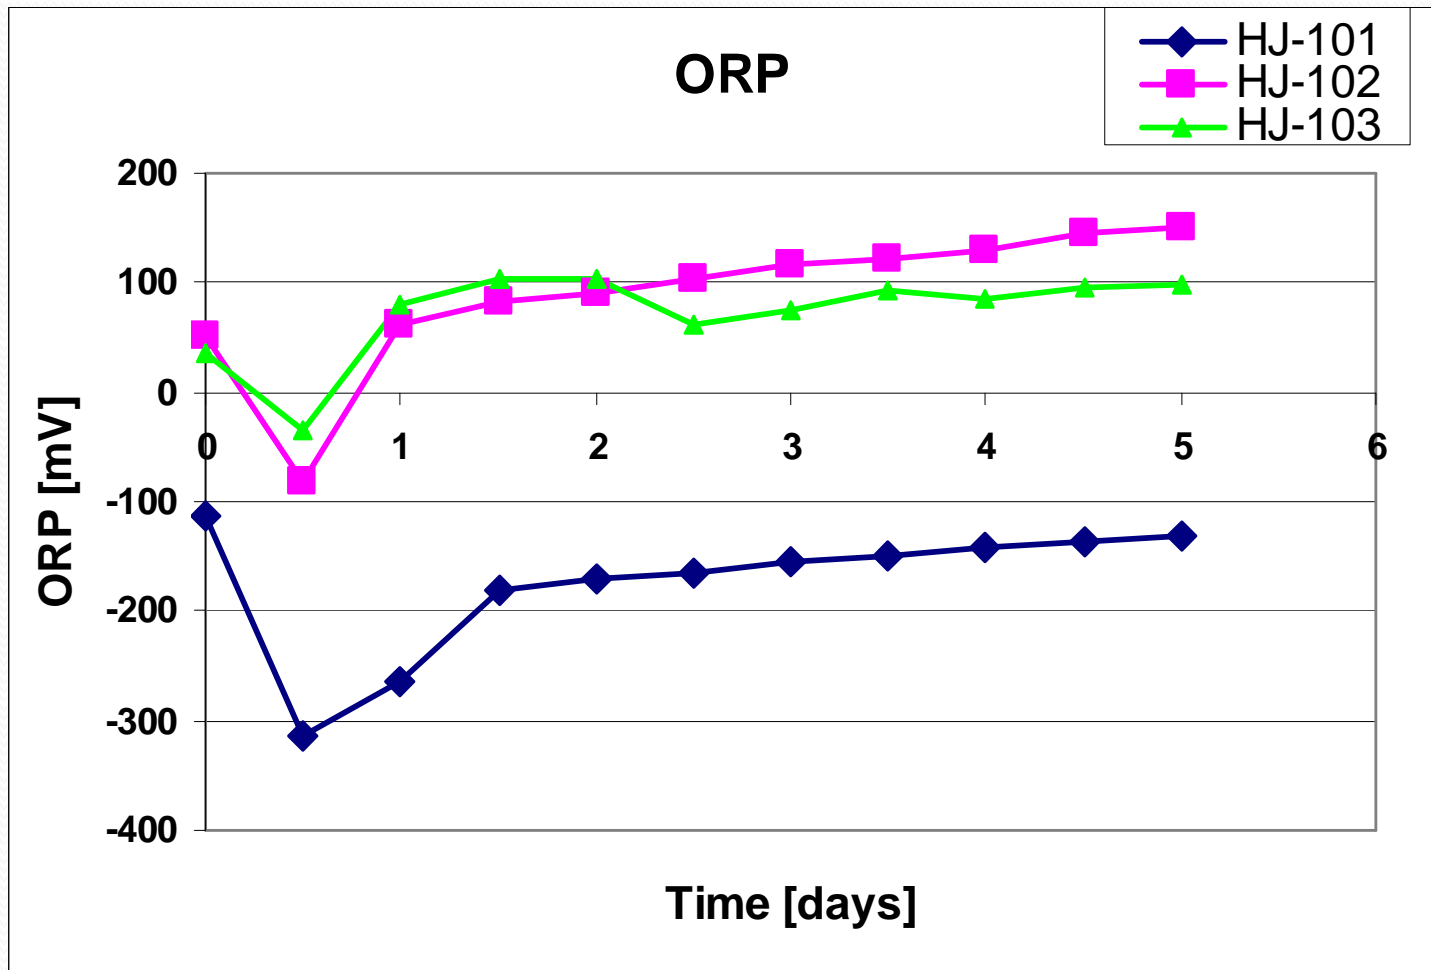
Results of injection 14.10.09 – changes in ORP

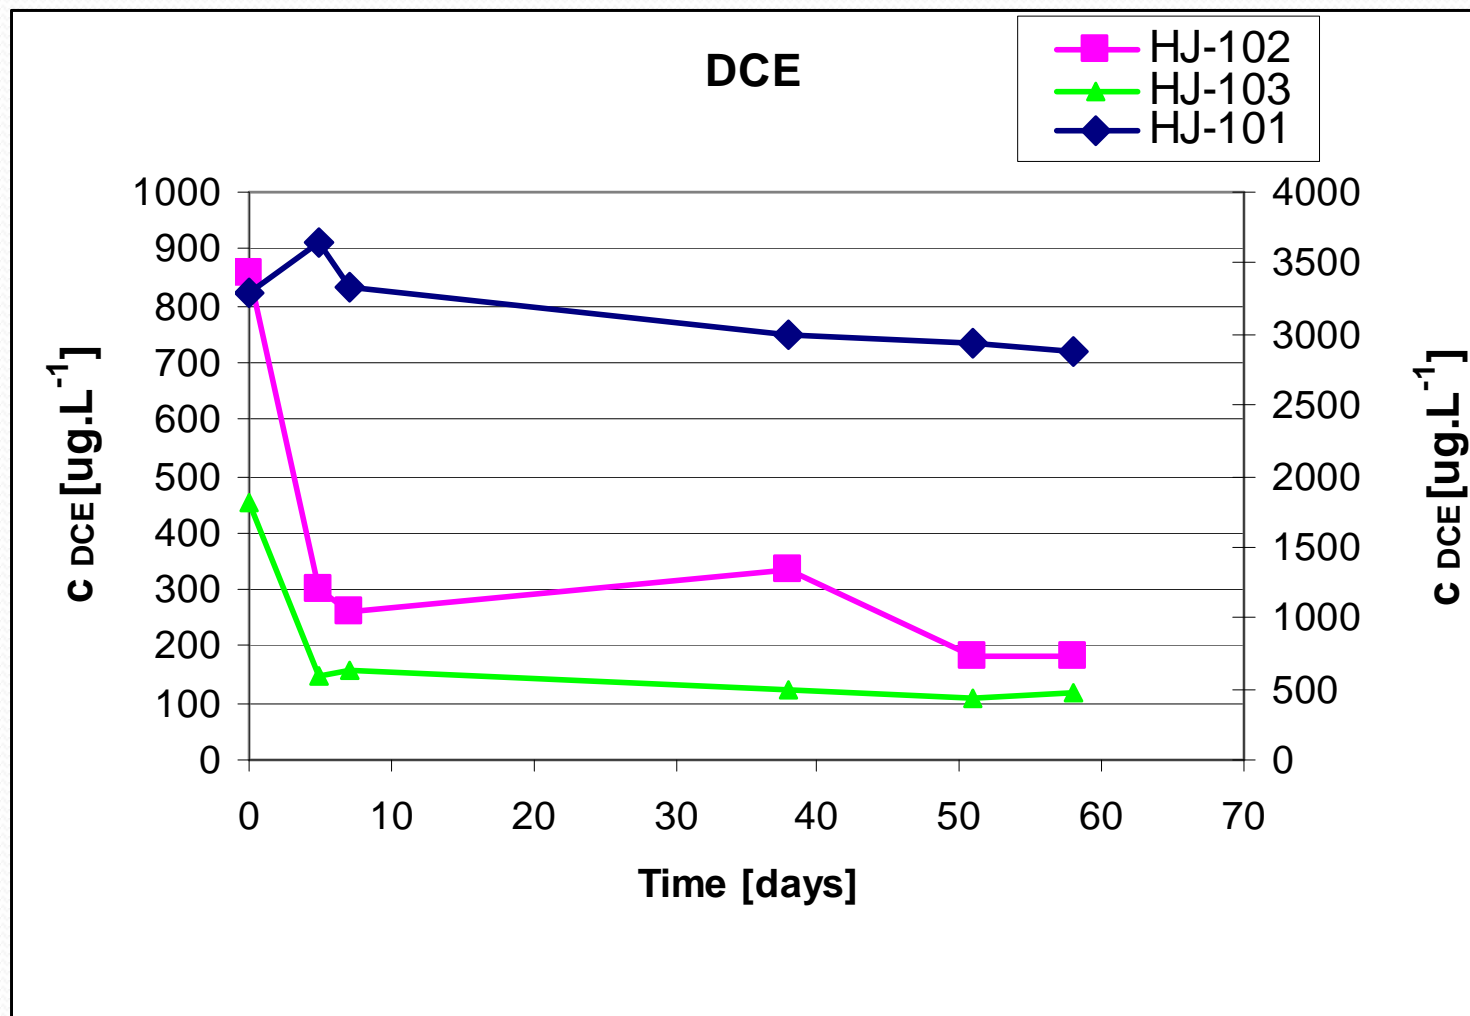
DCE reduction

- RNIP-10APS product showed sufficient efficiency in chlorinated hydrocarbons degradation
- to achieve more significant pollutant removal higher nanoiron concentration would be needed
- stabilized nanoiron showed high ability to migrate through the soil
