Exploration of Chinese Remediation Industry and Corporation between China&Europe

----- Striving to maintain our recognized leadership in Chinese remediation market by integrating innovative while environmentally-friendly approaches

3、 The Development of BCEER

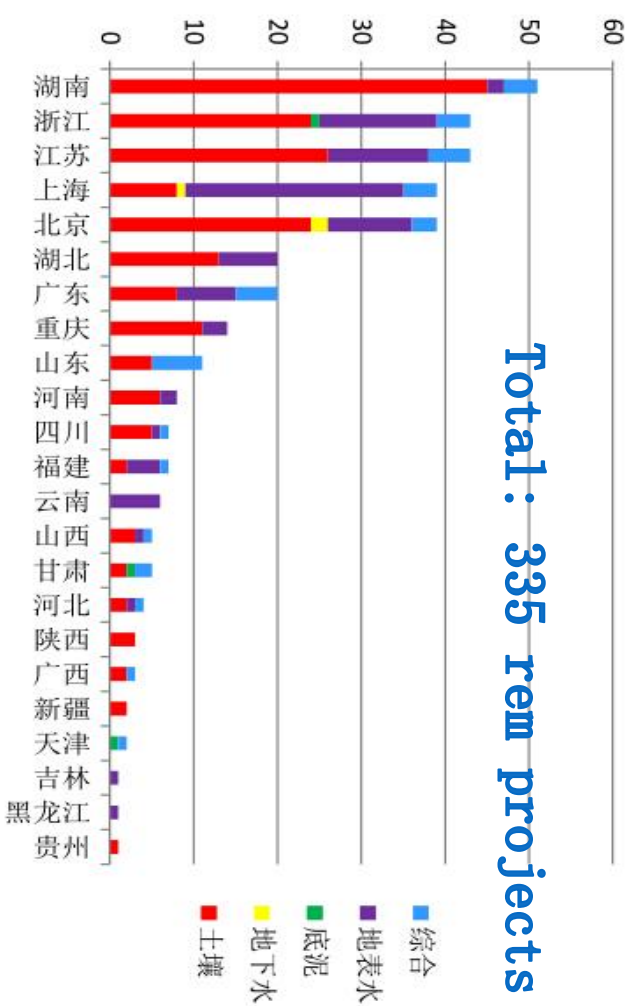
2006-2014 Remediation projects distribution map

57% are soil rem projects, mainly distributed in developed areas.

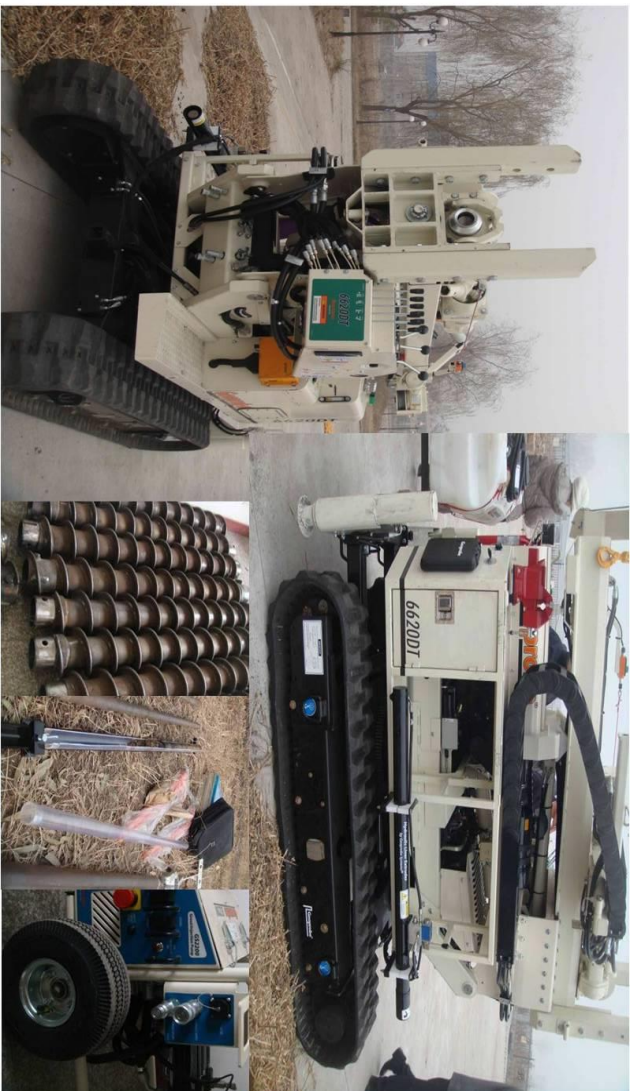
Geoprobe 6620 & 7822 drill rigs
 Geoprobe 6620 & 7822 钻机

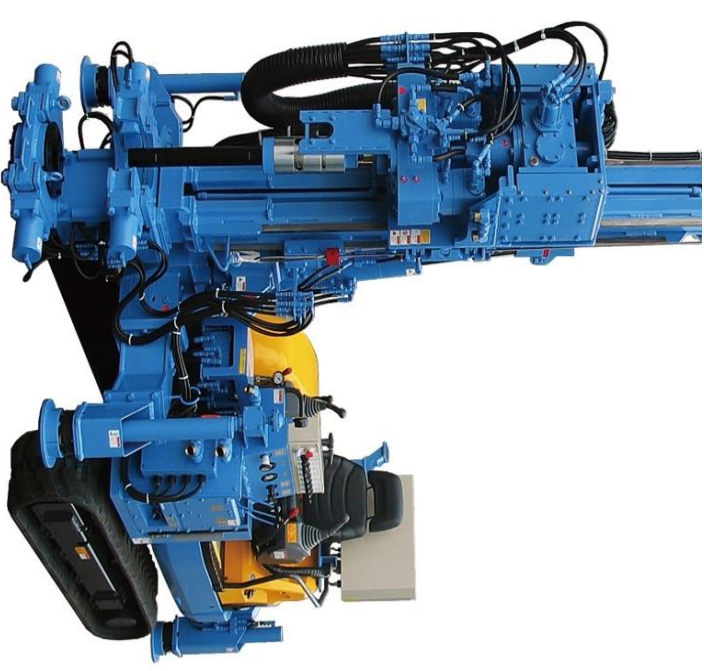
YBM ECO-7V drill rig
 YBM ECO-7V钻机

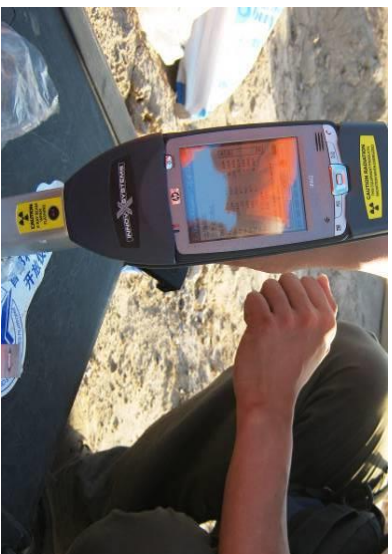
XRF

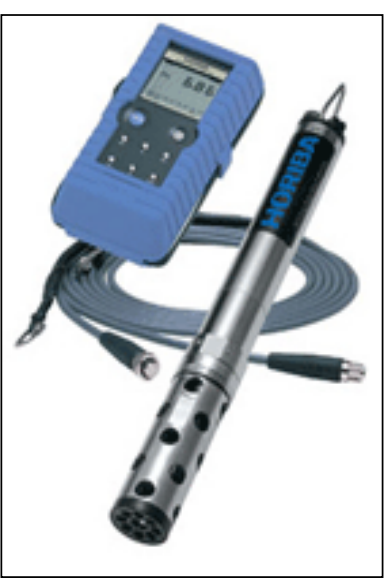
HORIBA

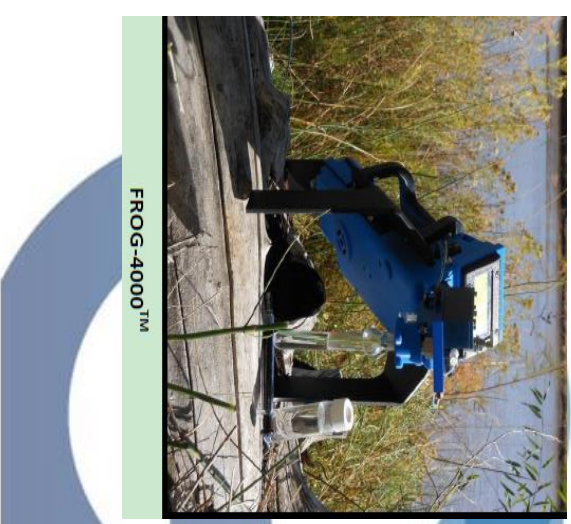
FROG-4000™

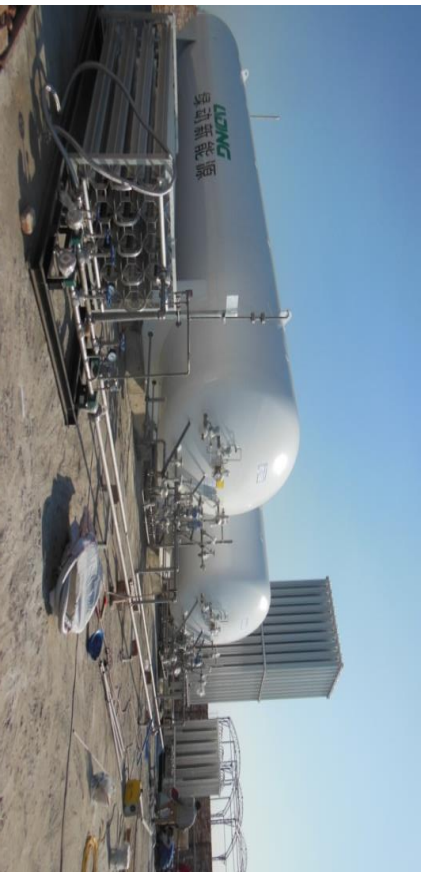
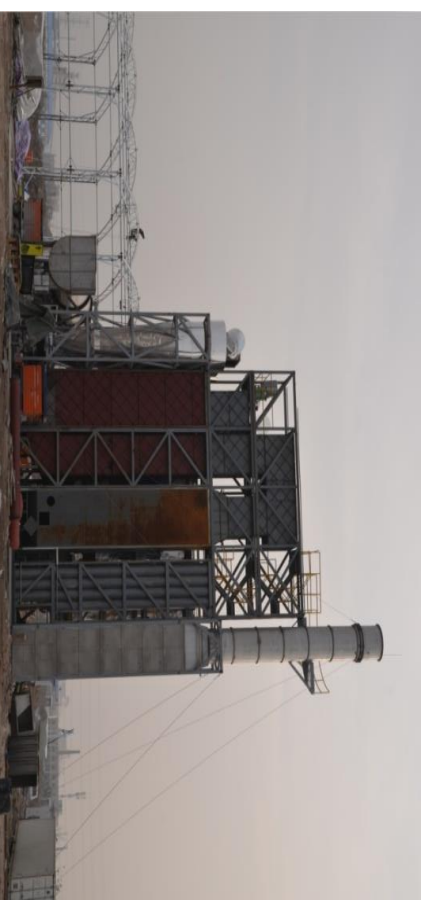
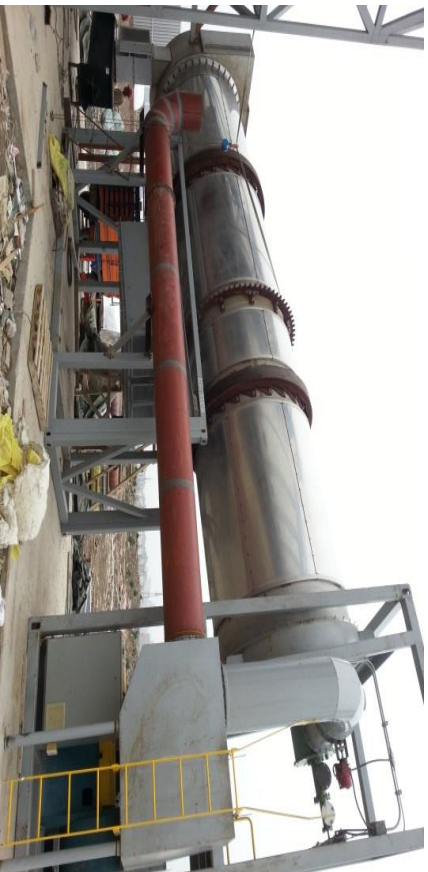
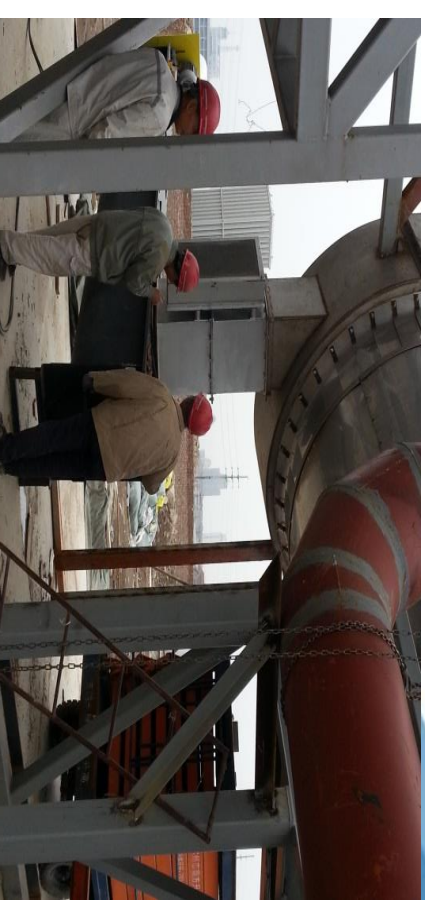
Low Temperature Thermal Desorption (LTTD)

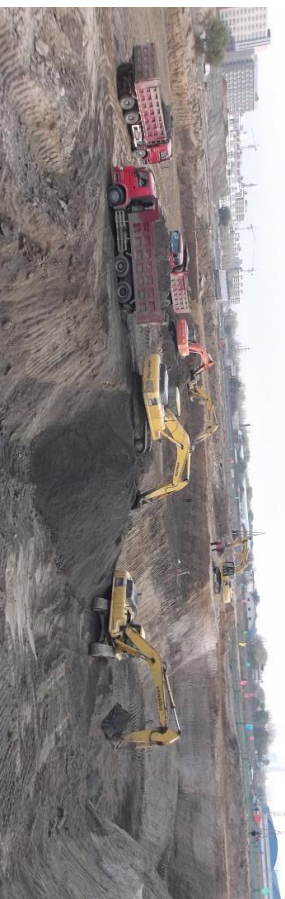
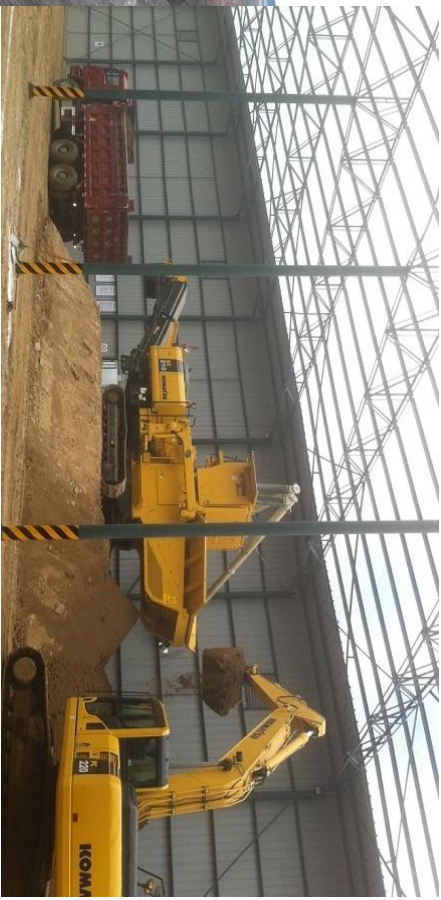
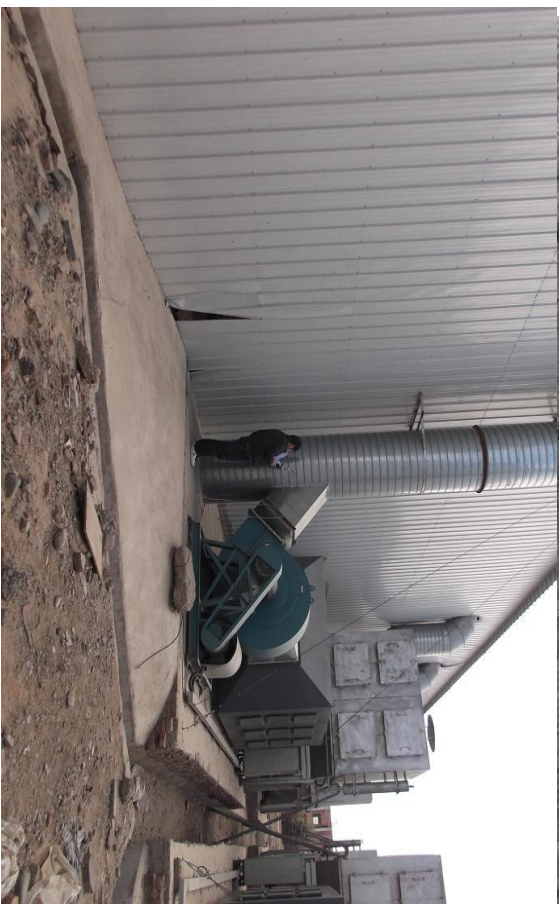
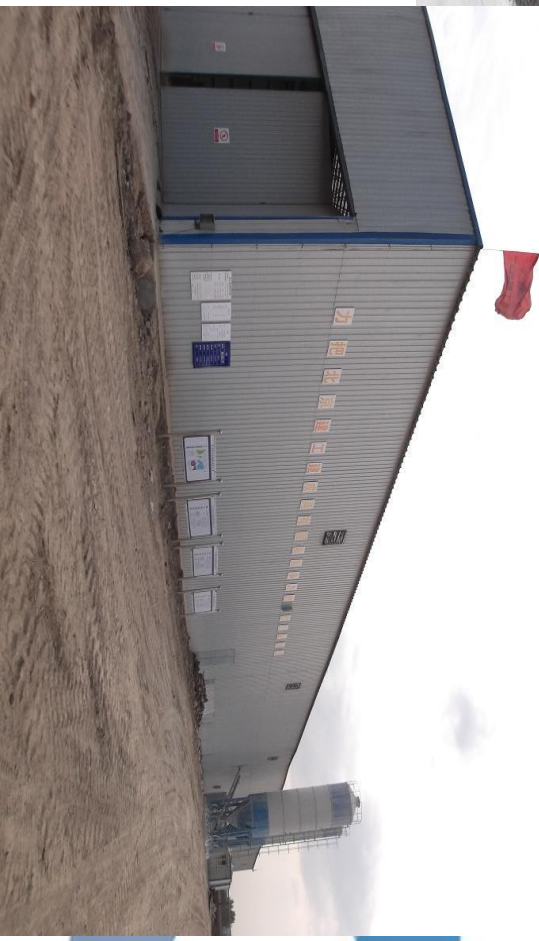
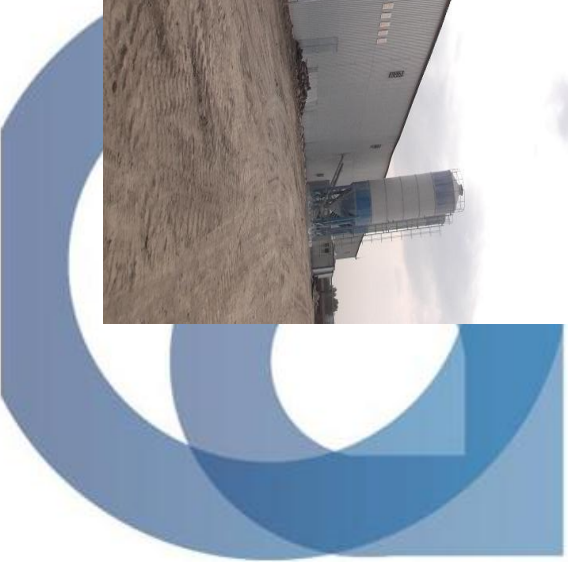
Mechanically-enhanced desorption

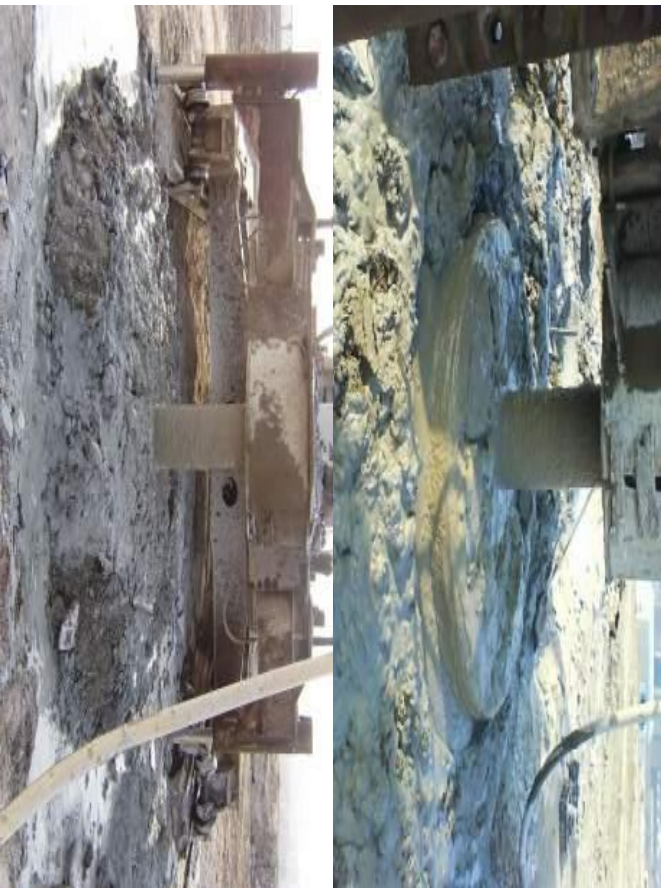
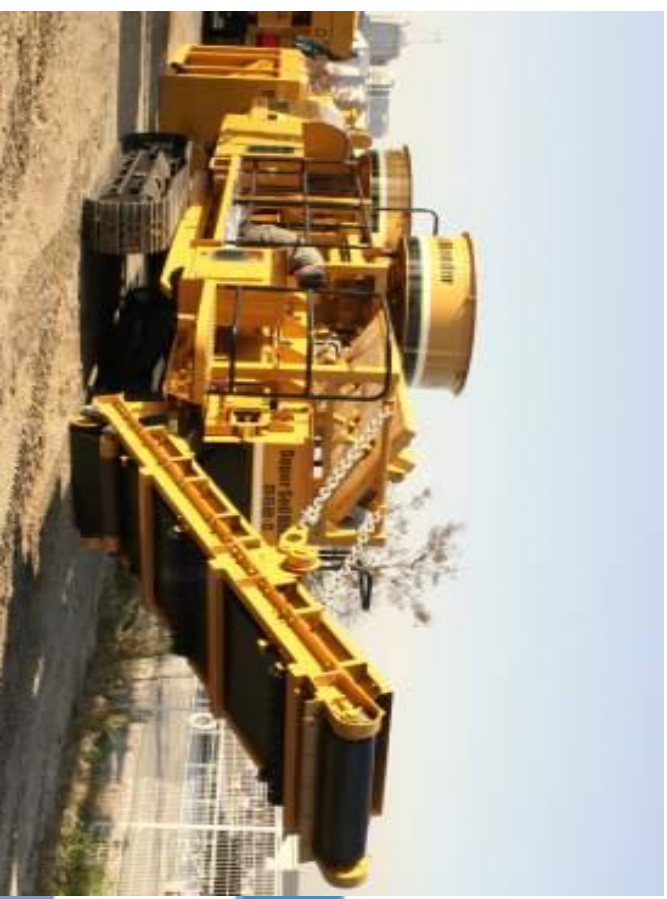
Solidification/Stabilization

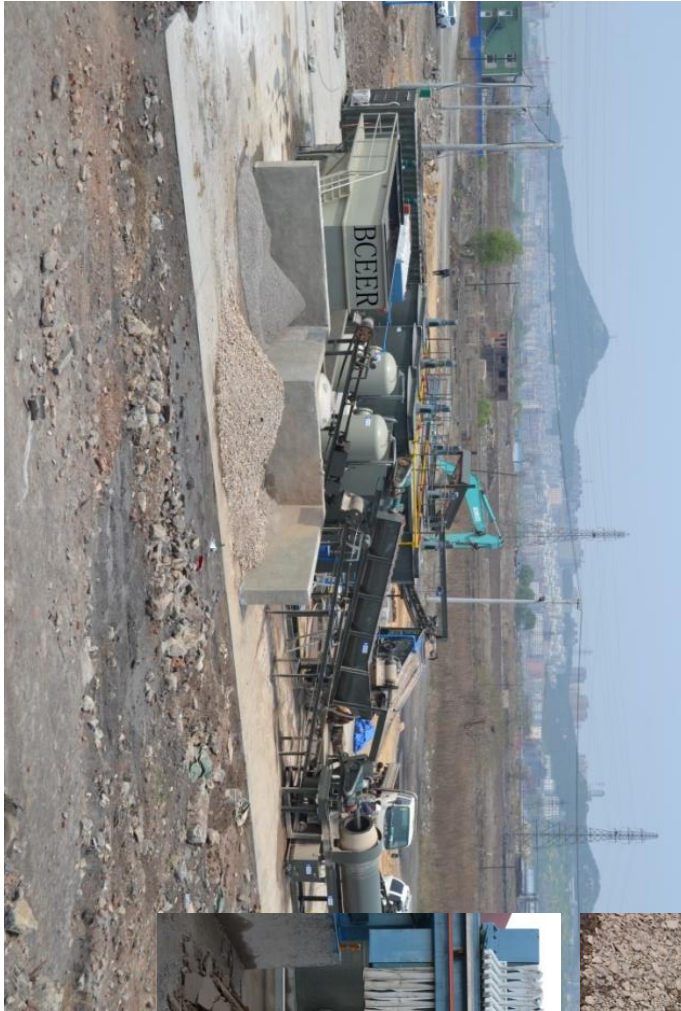
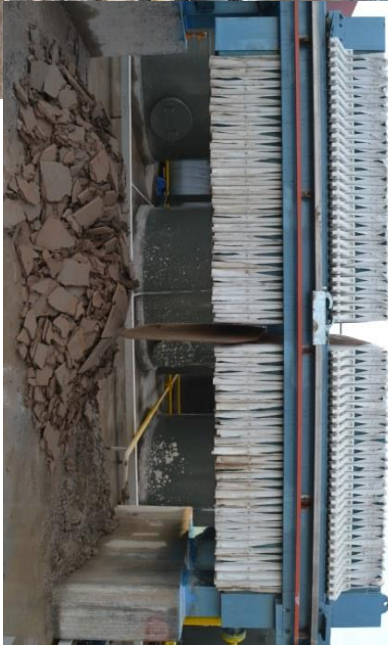
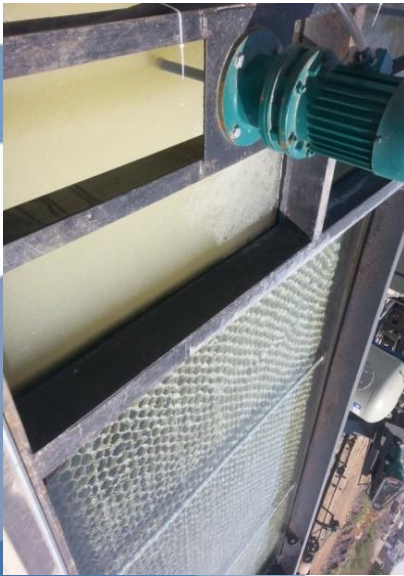
Soil Washing

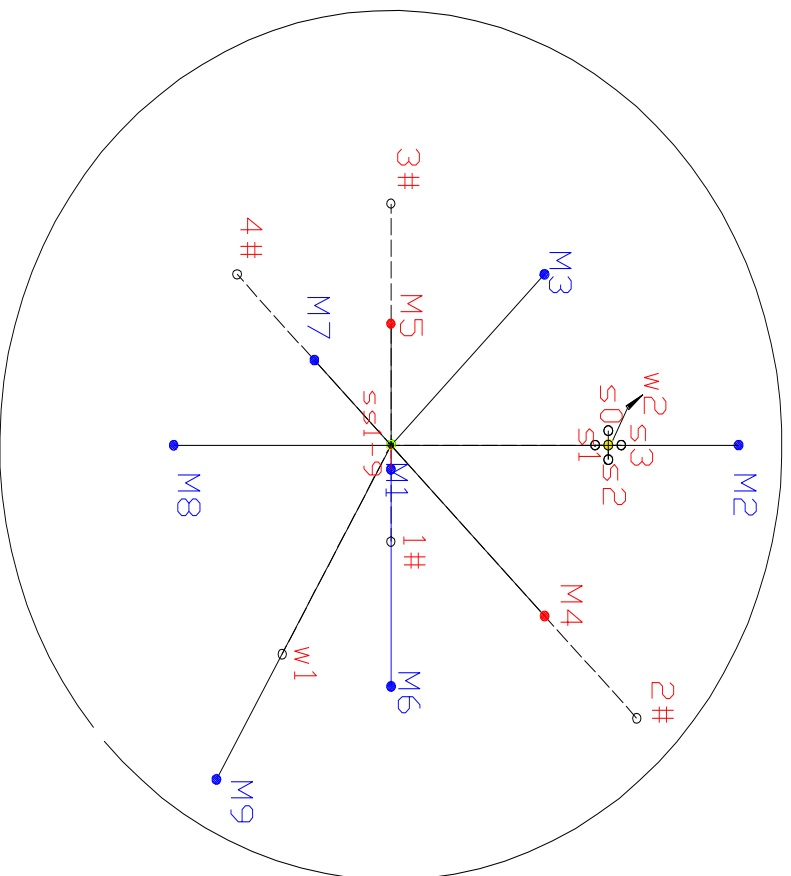
■ Site investigation :

- 9 conventional soil borings (red)
- 9 MIP survey locations (blue)

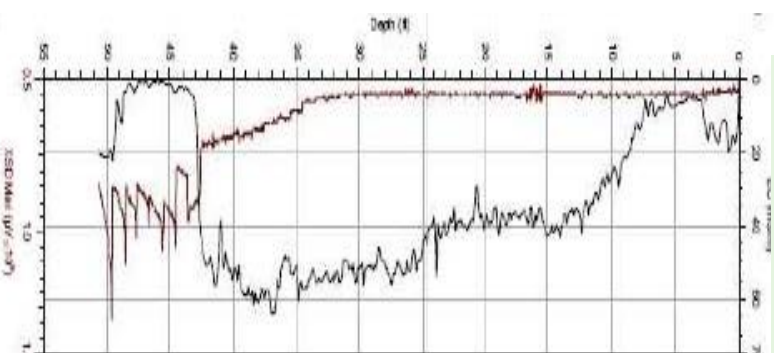
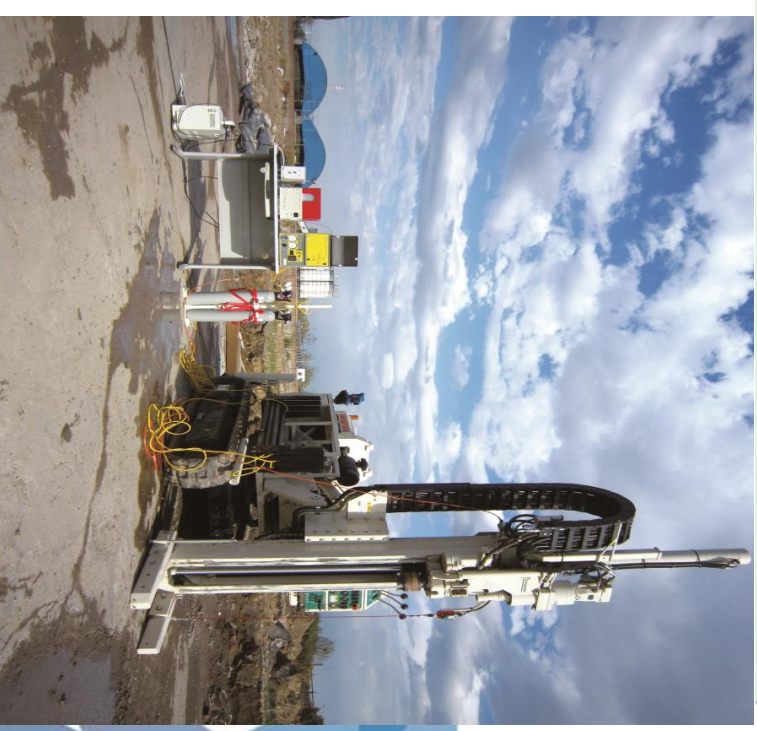
MIP作用:

- 1、即时探测污染剖面分布情况（色谱分析）
- 2、通过电导度判断土质

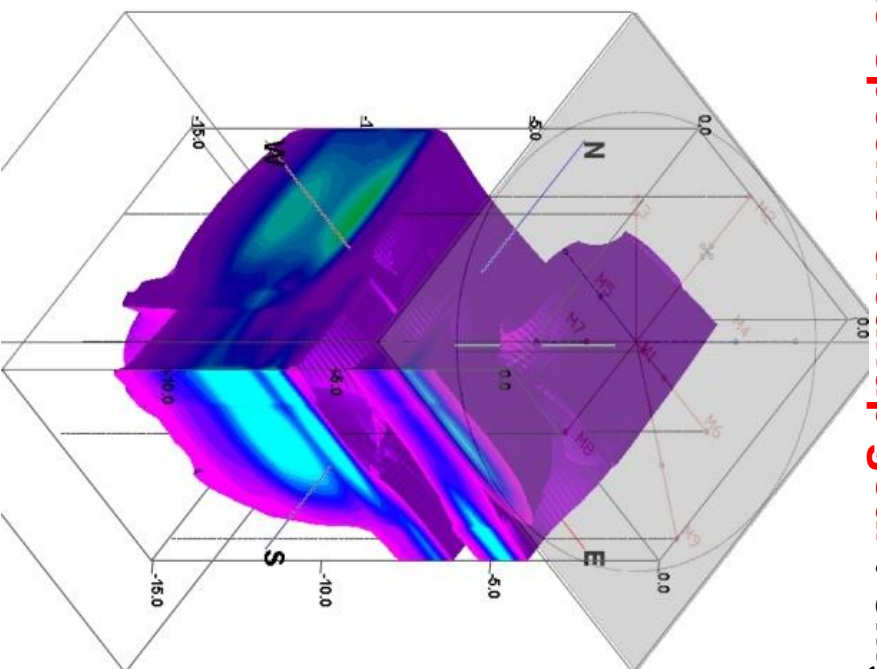
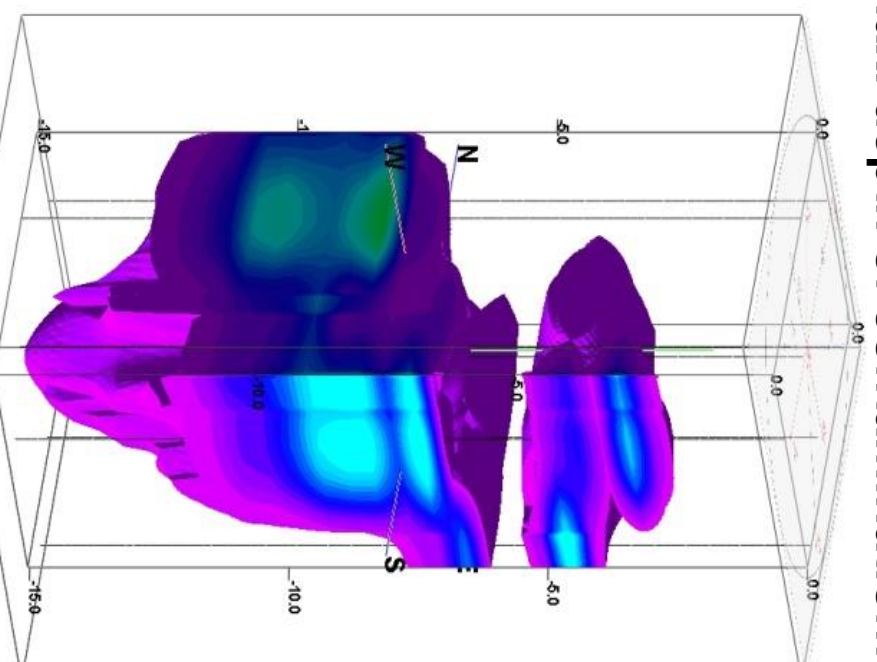
Spatial Distribution of Xylene Contamination in Soil

COCs : Xylenes

Site-specific cleanup goal : 5mg/kg; max. depth of contamination: 12m.

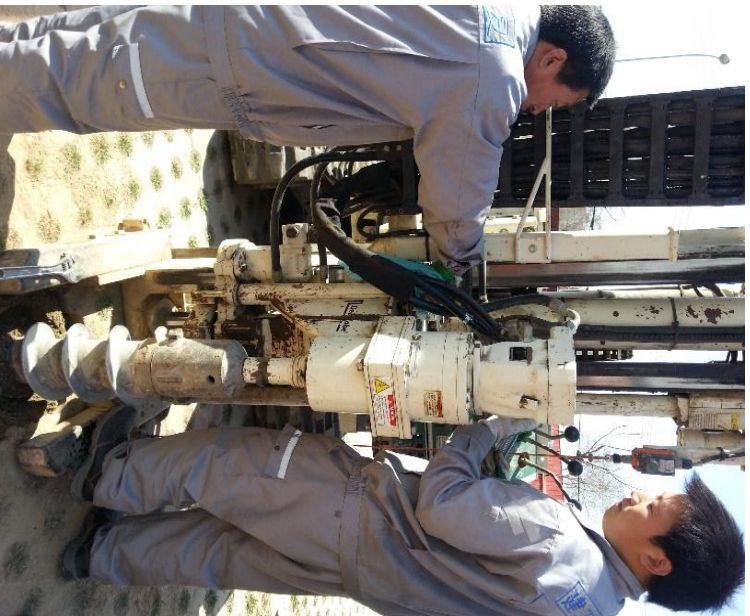
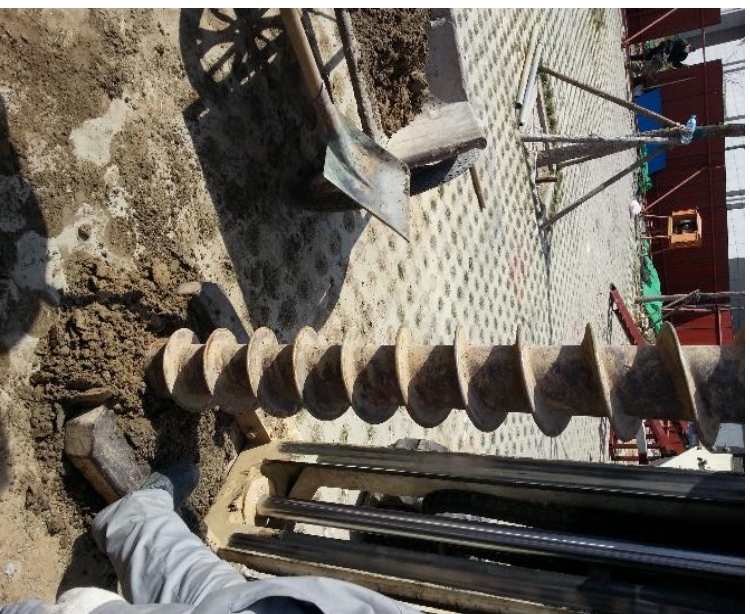
Geoprobe 建井

井口处理
