Intersol March 19th, 2014

Case Study:
Sediment Contamination by
Mercury and DDT and Ecological
Risk Assessment for Aquatic Biota,
Lake Maggiore, Italy

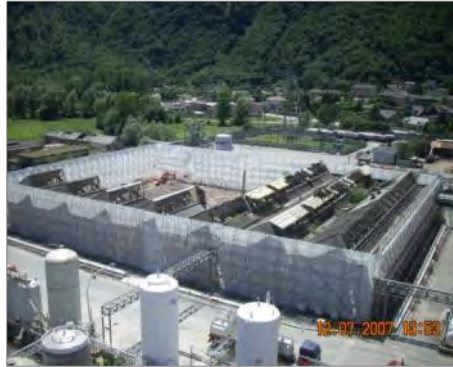
Pieve Vergonte Industrial Site History

Production facilities
construction for
the chlorine
production line

Fishing banned
due to DDT in fish
(>0.05 mg/kg)

Public authorities
prescribed
dredging/capping
of Pallanza Bay

Implementation of
DDT production line

Shutdown of DDT
production line

**Sediment
characterisation** to
support remedial
decision making

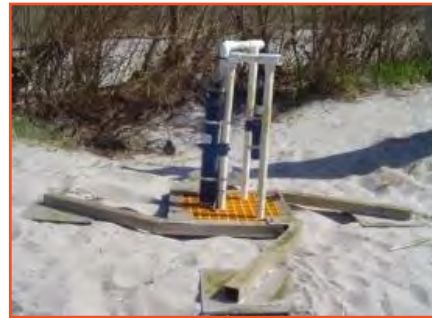
Sediment Transport – Input Data

FLOW VELOCITIES AND TURBIDITY MEASUREMENTS

- Aquadopp current metres, optical backscatter metres (OBS) and Acoustic Doppler Current Profiler (ADCP)

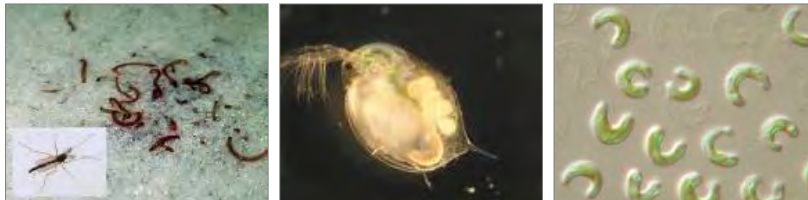
Benthos Toxicity Testing

C. riparius: 28 days exposure

- No significant relationships between any of the endpoints and DDx/Hg concentrations in sediments
- Tested concentrations represent full range of sediment concentrations

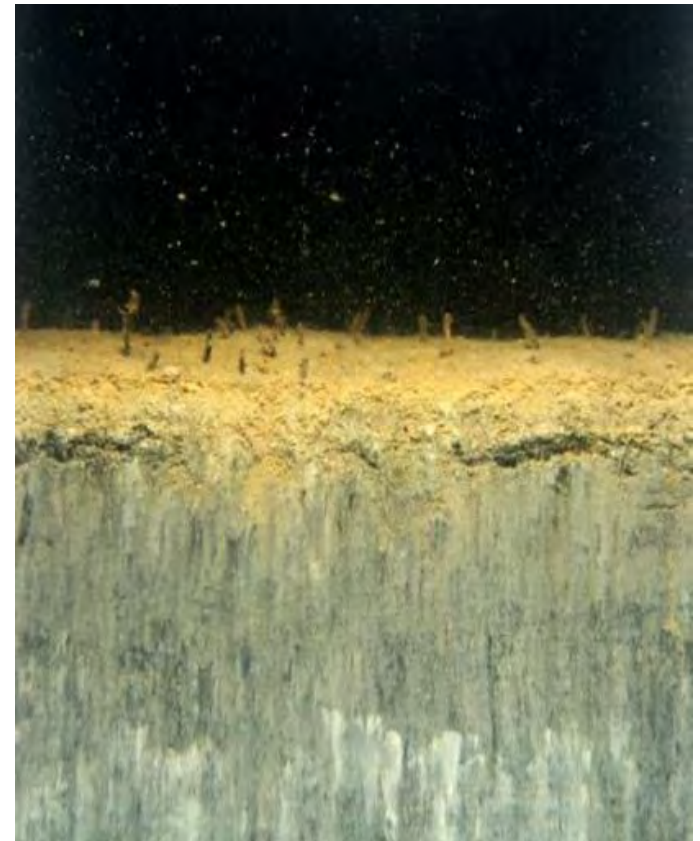
Benthos Biology – SPI Camera

SPI camera and plan
view camera survey

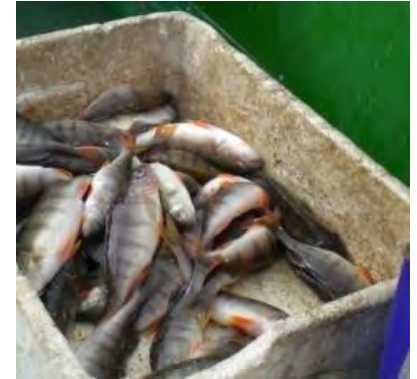
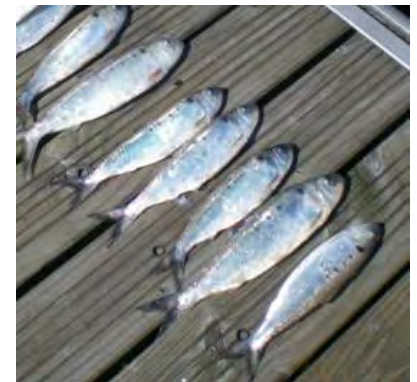
Fish Community

- Comparison of fish tissue concentration to literature-derived benchmarks protective of fish (~200 analysis on fishes of different trophic levels and age)
- Comparison of **surface water concentration** to water quality benchmarks
- (Water sampling campaign and analysis of previous studies)
- Fish fitness as function weight-length (endpoint for mercury)
- Evaluation of site specific studies on reproductive success

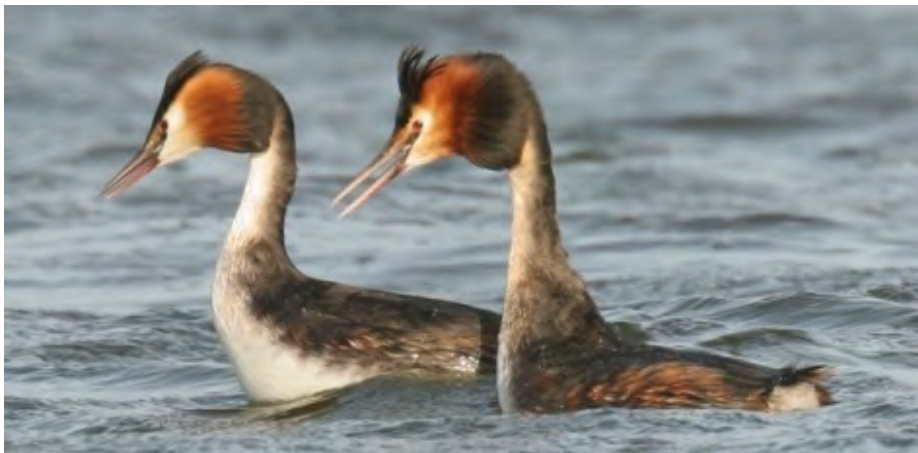
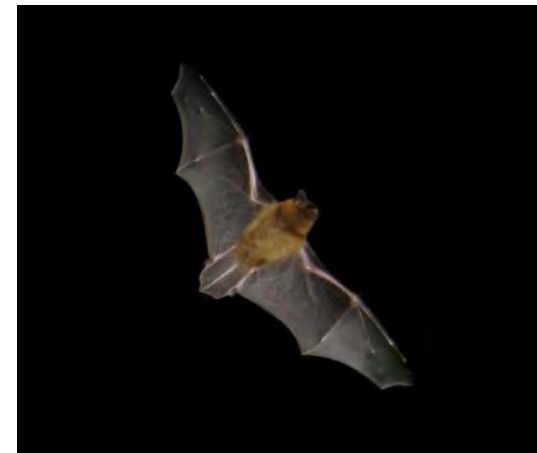
Wildlife

Evaluation of survival and reproduction of populations of fish-eating birds (grebes) and insectivorous mammals (bats):

- Comparison of contaminants ingested doses by diet with TRV protective reproductive success
- Evaluation of site specific studies on grebe eggs shell thickness and DDT concentration
